Analyst[®] 1.7 Software with HotFix 1

Release Notes

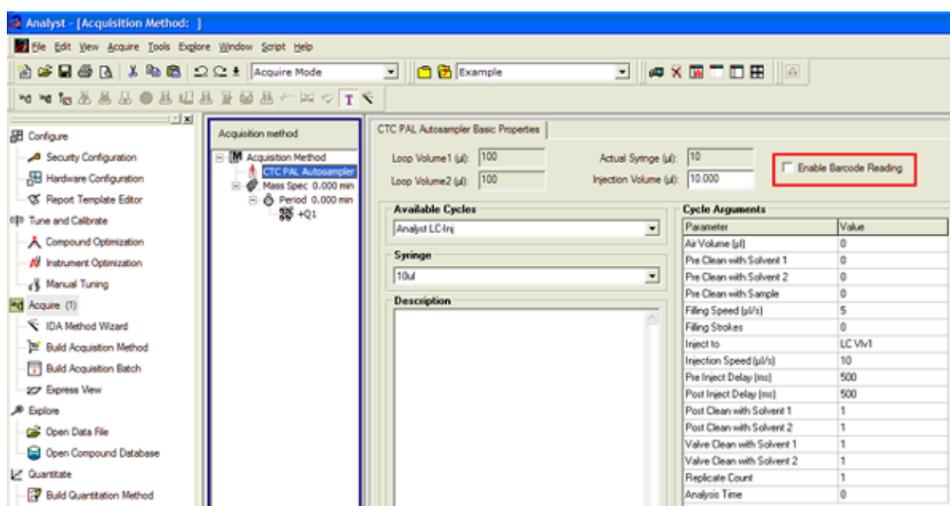
The CTC PAL Autosampler Method Editor now contains an “Enable Barcode Reading” check box. Selecting this check box (flag ON) activates the barcode reading and storing feature. Clearing this check box disables barcode reading.

Figure 3-1 Enable Barcode Reading check box

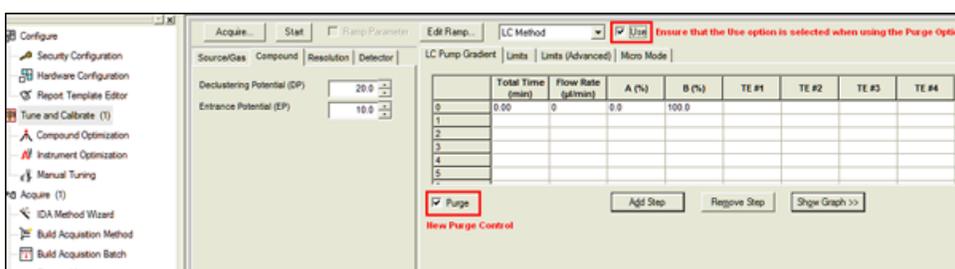
The Analyst[®] software supports this functionality in both the Acquisition Method Editor and Manual Tuning through the Purge option.

Figure 3-3 Purge option in Manual Tuning

When the Purge option is activated, the Agilent 1290 Binary Pump opens the purge valve, allowing system purging.

Users can either use Manual Tuning to purge or prime their system, or they can create an acquisition method to be used exclusively for purging. This method can be submitted via the Acquisition Batch Editor in the same manner as acquisition methods. In this scenario, the mass spectrometer acquires data to the specified wiff file.

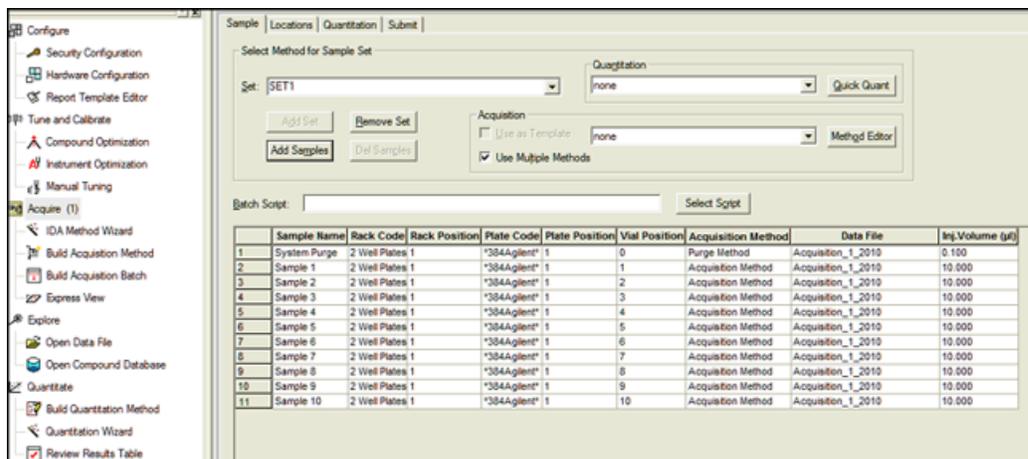
Figure 3-4 Example acquisition batch with a purge method before acquisition
